Assessment of Wetland Impacts and Wetland Compensation Options

Hartlen Point, Eastern Passage, NS
DCC Project No. IE036102_74469KN

Final Report

211207.00 • March 2023

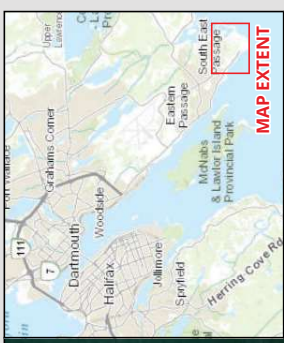
DATE: 2023-03-17	PROJECT: 211207	FIGURE: 5.1
DRAWN BY: SF	CHECKED BY: LM	APPROVED: JB

CBCL developed four preliminary concepts for onsite compensation options for consideration by DCC/DND and CWS. These compensation options are described in the following sections. The locations of these potential options within the Study Area are depicted in Figure 5.1.

Additional options that were considered as part of this assessment include the management of invasive species, such as Japanese Knotweed, which was observed on site in locations identified in Figure 5.1. However, the elimination of Japanese Knotweed has often proved unsuccessful, and this option was, therefore, not considered feasible for this site.

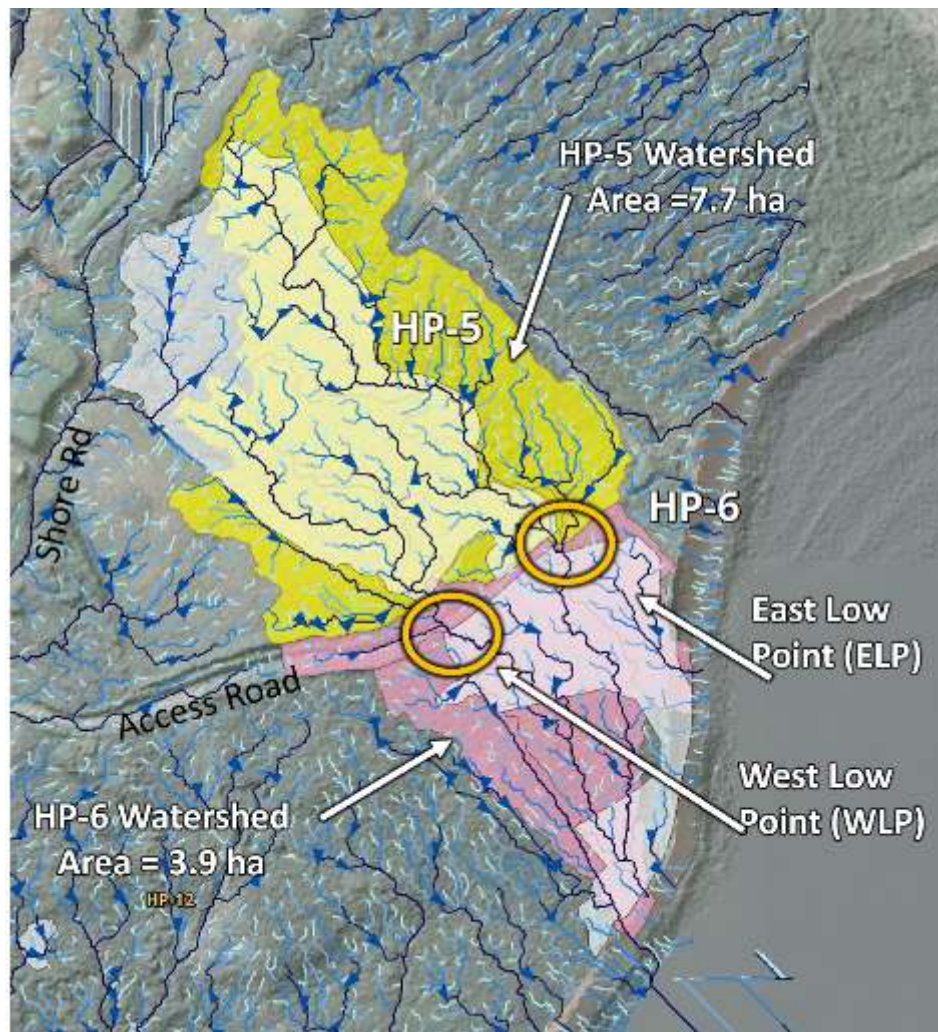
Figure 6.1: Watersheds Draining to Wetlands HP-5 and HP-6 under Existing Conditions.

Wetlands HP-5 and HP-6 drain a total area of approximately 12 hectares (ha). As shown in Figure 6.1, the watershed draining towards HP-5 is bounded by a gravel access road, Shore Road, and golfing grounds. HP-6 receives flows from HP-5 when these overtop the gravel access road at the two low points shown in Figure 6.1. HP-6 also receives flows from its surrounding watershed, shown in pink in Figure 6.1. Runoff continues to drain unrestricted through HP-6 towards the shoreline. The flow paths shown in Figure 6.1 were calculated through a slope analysis of the 1-m Digital Elevation Model (DEM) using 2019 provincial Light Detection and Ranging (Lidar) data.

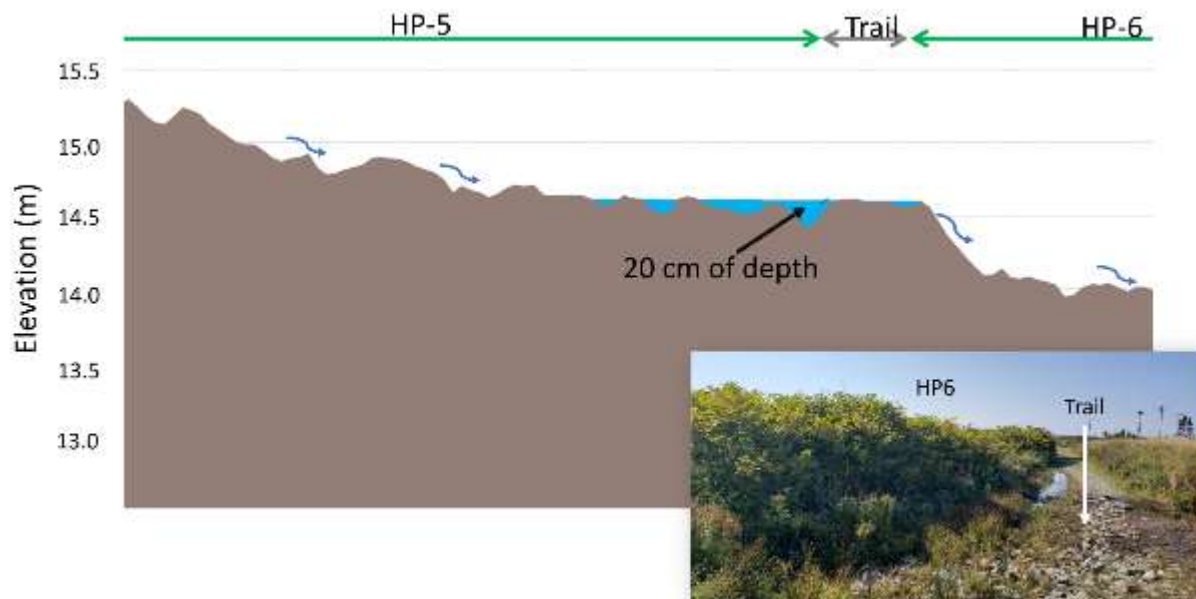
Figure 6.2: Topographic Profile along the East Low Point of the Gravel Access Road.

A topographic profile delineated along the flow pathway through the East Low Point (ELP) shown on Figure 6.2, indicates that the road is approximately 0.20 m higher than the wetland elevation. The upstream (or upgradient) section of HP-5 features a steep slope where the drainage is only partly restricted by the gravel access road. As depicted in Figure 6.2, the gravel access road through wetlands HP-5 and HP-6 leads to only limited water backup or pooling in HP-5. Except for very low runoff flows, most of the stormwater flowing through HP-5 may travel unrestricted to HP-6. Smaller rainfall events and subsequent runoff is likely to pond throughout HP-5 in the small depressions created by the natural irregular shape of the terrain. Evidence of this flow pattern can be observed in the site photograph shown in Figure 6.2. This suggests that the installation of culverts at the existing ELP and West Low Point (WLP) along the gravel access road may result in limited changes to the existing wetland conditions (e.g., vegetation type, hydrology, functions) observed in HP-5 and limited enhancement to HP-6.

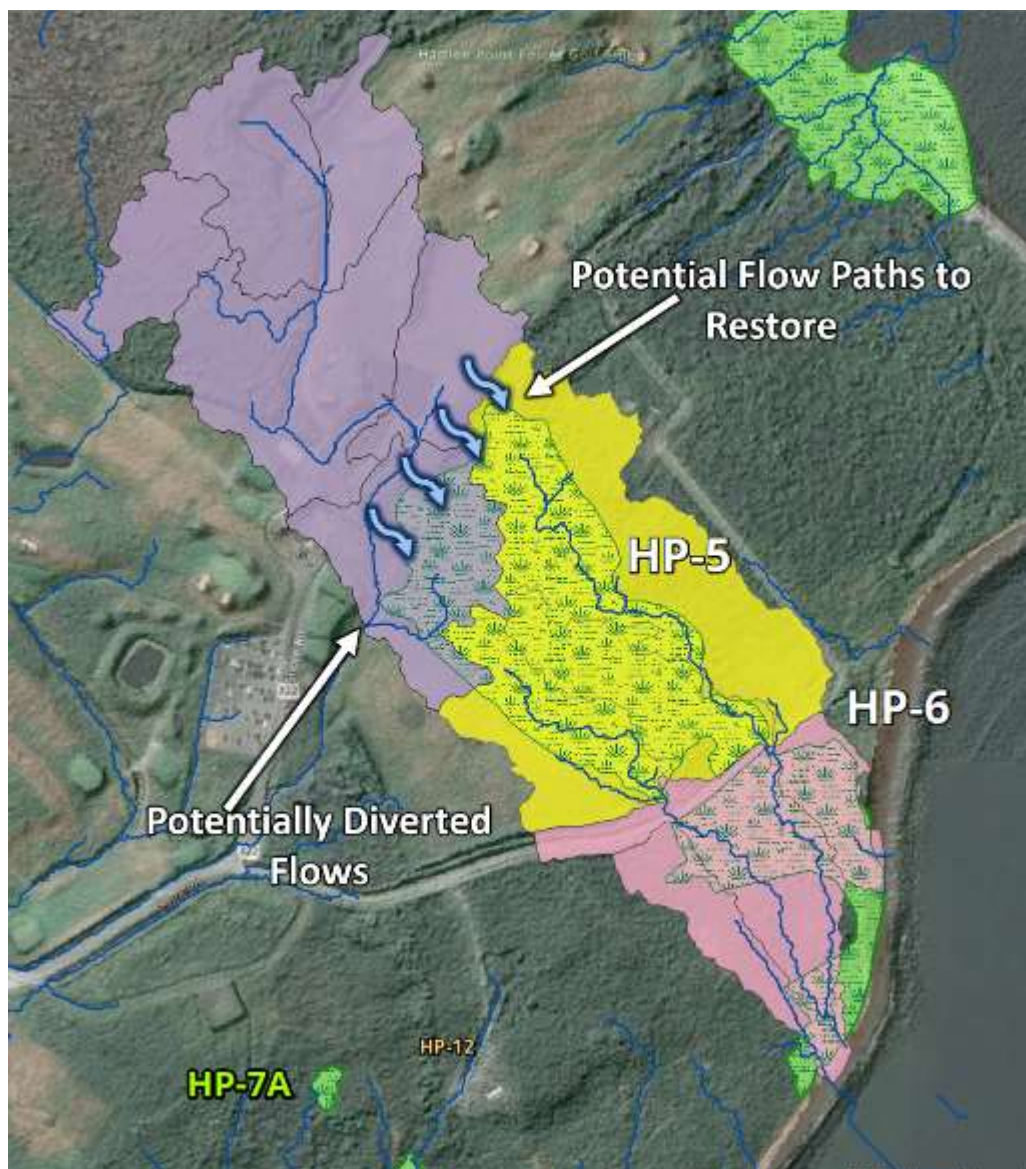
Figure 6.3: Current Location of Flow Paths Potentially Diverted During Site Development and the Location of Potential Flow Paths for Restoration.

An analysis of the existing topography and the estimated flow paths suggests that the 6.5 ha area located north-northeast of Shore Road (shown in Figure 6.3) may have drained towards HP-5 before the golf course was developed. The topography and flow paths shown in Figure 6.3 suggest that runoff flows from this area were diverted southwesterly along the south face of Shore Road during development. Because the size of this potentially diverted area is close to the size of the watershed currently draining directly to HP-5, this suspected diversion may have resulted in substantial changes to the type and function of wetland HP-5. Therefore, efforts to restore hydrology in HP-5 to pre-development conditions may require the restoration of the flow paths identified in Figure 6.3.

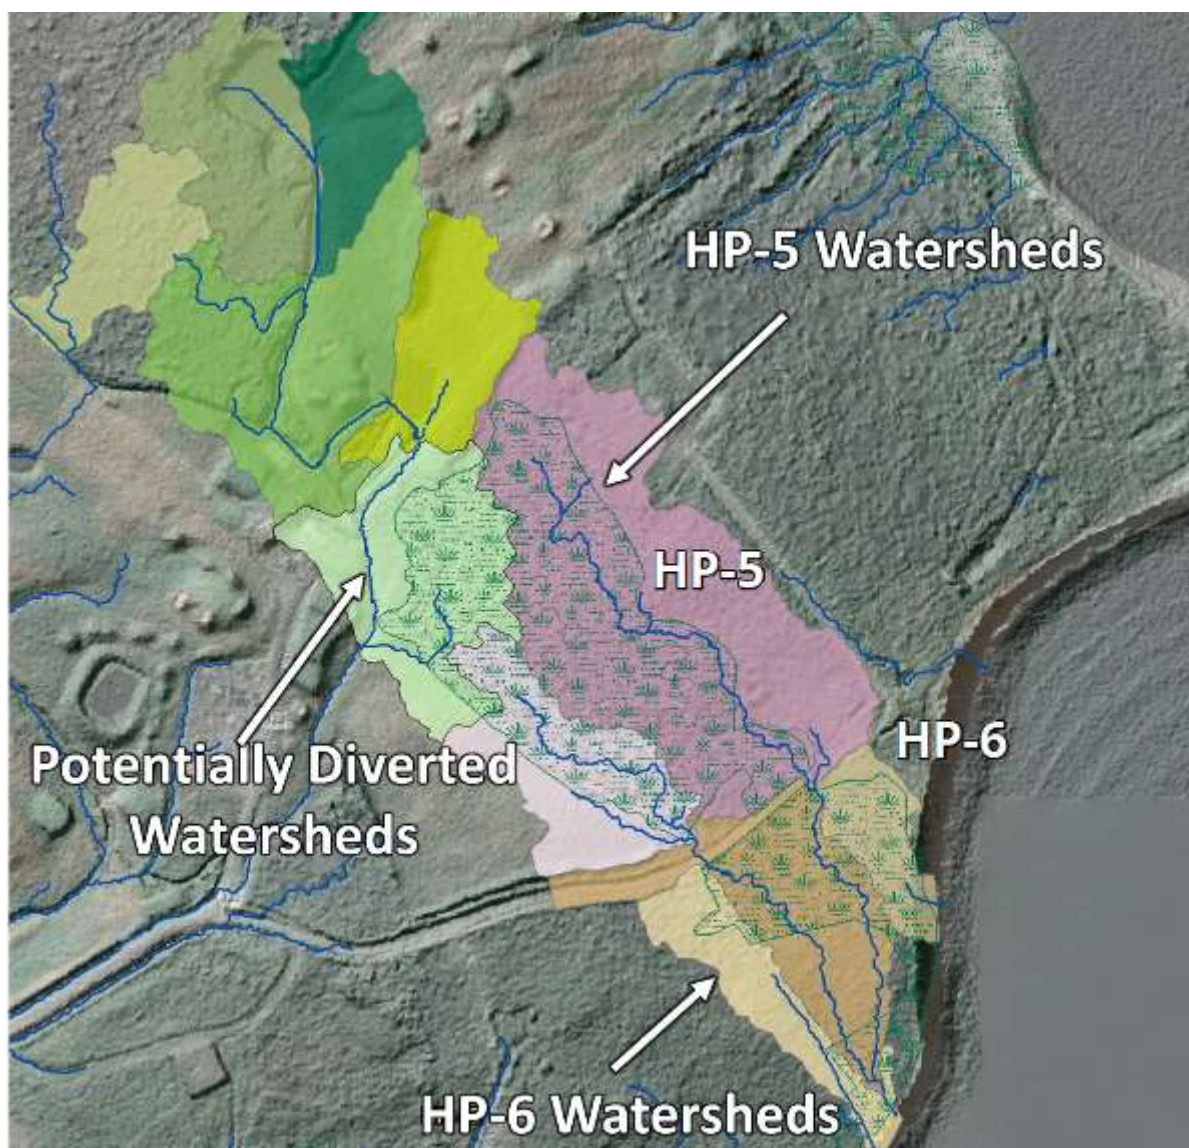
Figure 6.4: Watersheds Draining to HP-5 and HP-6.

The watersheds currently draining towards HP-5 and HP-6 and the watersheds north-northeast of Shore Road (potentially diverted during construction) were delineated based on the Lidar DEM available from the NS database, GeoNOVA. To account for the variability of land cover and slopes in the runoff calculations, the drainage area was divided in a series of smaller sub-catchments as shown in Figure 6.4. The watershed characteristics identified in this assessment are summarized as follows:

- ▶ **Slopes:** Slopes within the watershed range between 0.5% and 2%, with the land surface becoming steeper south of Shore Road.
- ▶ **Land Cover:** Most of the land cover within the watersheds is vegetated. Land uses associated with golfing activities feature low (maintained) grass, whereas areas of the watersheds surrounding the golf course consist of shrub and forested habitat, with Manning's (n) roughness coefficients ranging between 0.15 and 0.40.
- ▶ **Permeability:** Except for the wetland covered surfaces, most of the watershed area is considered permeable.
- ▶ **Soils:** According to the Natural Resources Canada (NRC) soil survey, the underlying substrate surrounding the wetlands consists mostly of sandy clay loam soils. The NRC soil survey identifies the substrate underlying HP-5 and HP-6 as peat.

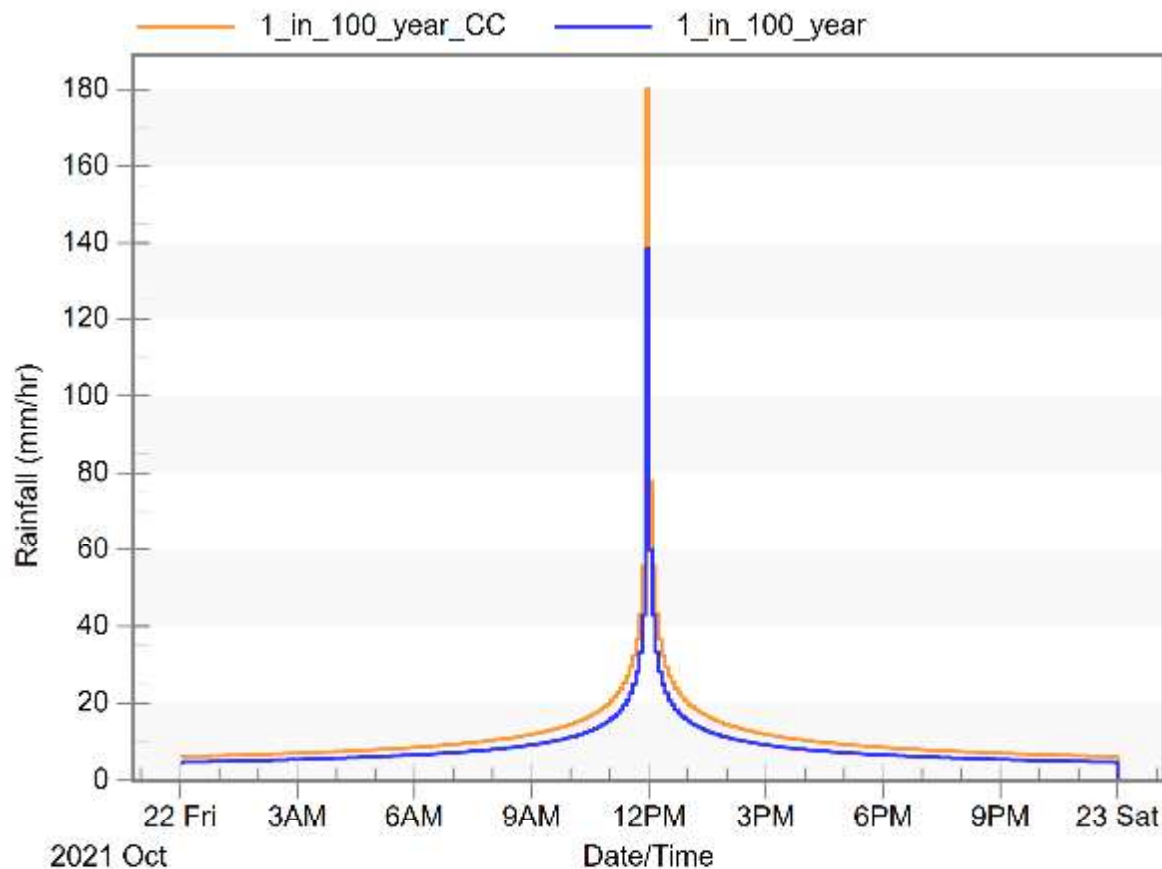
Figure 6.5: 1 in 100-year Rainfall Time Series for Existing and Projected Climatic Conditions.

Design Event: This assessment assumes a culvert life cycle of approximately 75 years with climatic conditions projected for the 2070 to 2099 period with a 30% rainfall increase. Based on the NS Environment Watercourse Alteration Standards, the 1 in 100-year flows were selected as the design criteria for the hydraulic capacity of the proposed culverts. Figure 6.5 shows the 1 in 100-year hyetographs calculated using the Chicago Distribution method and the IDF curves for the Shearwater Climate Station. These time series were used as inputs in the hydrologic model of the watershed.

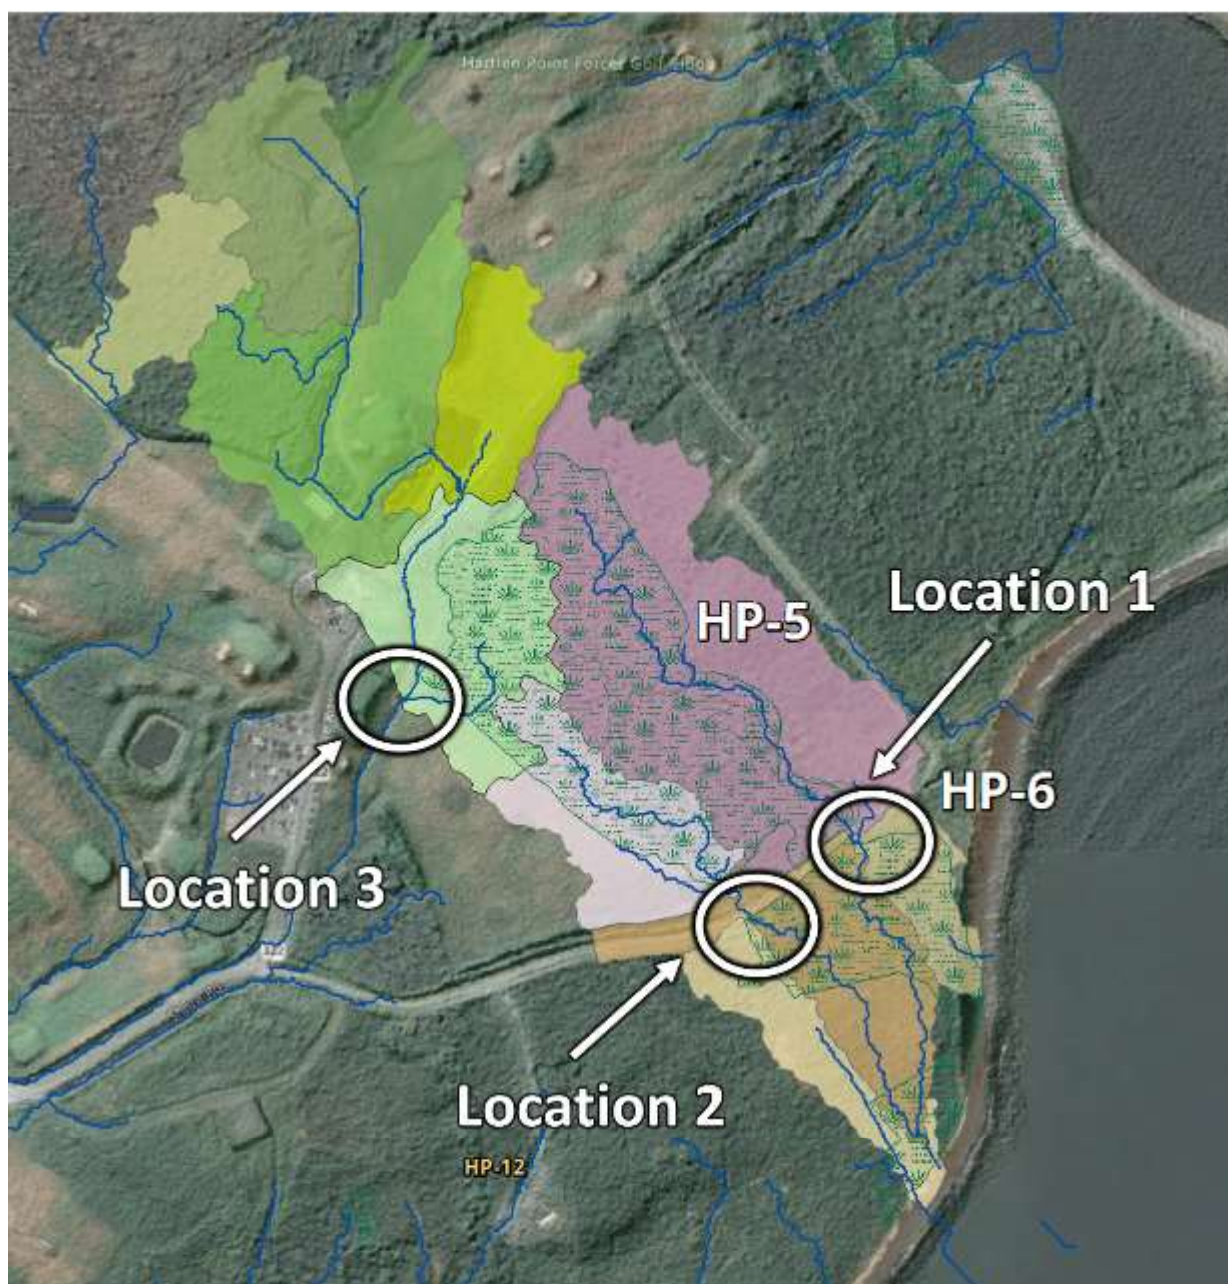
Figure 6.6: Locations at which 1 in 100-year Flows (under Existing and Climate Change Conditions) were Calculated.

Location	1 in 100 -year Flow – Existing Conditions (m ³ /s)	1 in 100-year Flow Climate Change Scenario (m ³ /s)
Location 1	0.655	0.897
Location 2	0.204	0.281
Location 3	1.172	1.629

Flows calculated at Location 1 and Location 2 were used as inputs to size the proposed culverts to maintain hydrologic connectivity between HP-5 and HP-6 by conveying water under the road rather than overtopping and washing out the road (Option A). Flows calculated at Location 3 were used as inputs in the calculation of culvert sizes for a scenario where drainage to wetland HP-5 from the area north-northeast of Shore Road is restored (Option B).

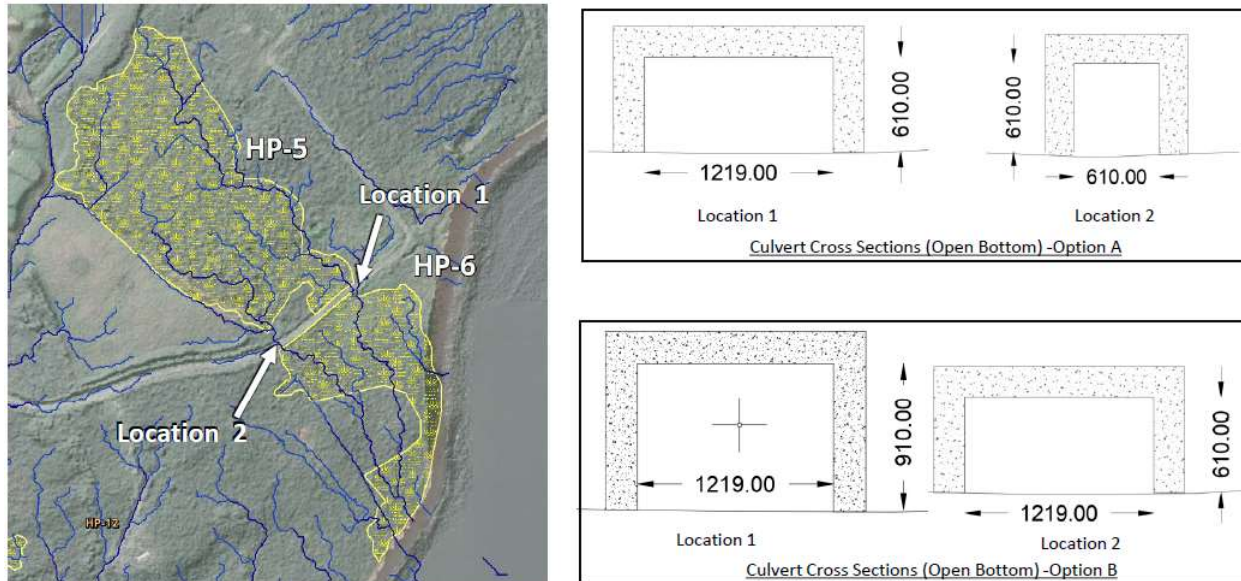
Figure 6.7: Concept Sketches of Culvert Cross Sections for Option A and Option B.

Results of the hydraulic assessment indicate that installing a 610 mm x 1219 mm and a 610 mm x 610 mm open-bottom box culvert at Location 1 and Location 2, respectively, will provide the minimum hydraulic capacity required to convey the calculated 1 in 100-year peak flows under the projected climatic change conditions for Option A.

If restoring drainage from the area north-northeast of Shore Road to HP-5 is considered (Option B), larger structures would be required. This is because runoff flows would increase as they would also include those calculated at Location 3. For this scenario, the calculations indicate that installing a 914 mm x 1219 mm and a 610 mm x 1219 mm open-bottom box culvert at Locations 1 and 2, respectively, would provide the minimum hydraulic capacity to accommodate 100-year peak flows under projected climatic change conditions. These results are further summarized in Table 6.4. A concept sketch of the culvert cross section for each Option A and Option B is provided in Figure 6.7.

Option A		Option B	
Location 1	Location 2	Location 1	Location 2
610 mm x 1219 mm	610 mm x 610 mm	914 mm x 1219 mm	610 mm x 1219 mm

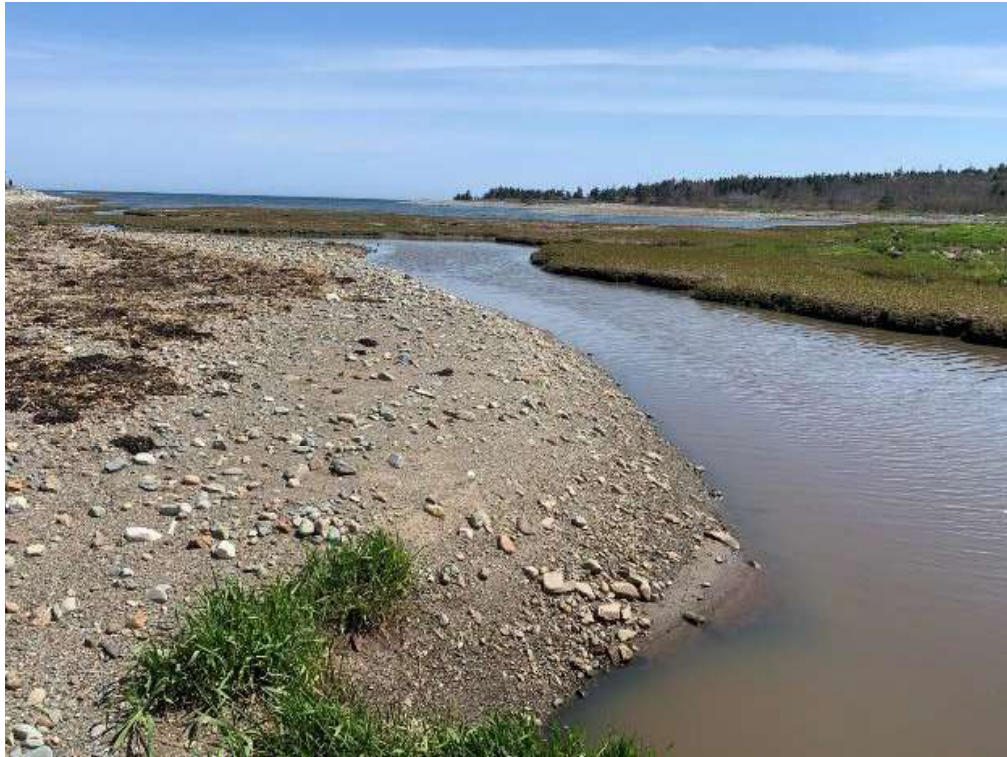
Photo 1: View (Looking Southeast) of Tidal (Salt Marsh) Portion of HP-2.

The tidal portion of HP-2 is a salt marsh that has developed within Hartlen Cove (Appendix A, Photo 1). The salt marsh, which is larger than mapped by WSP (2018), forms a narrow fringe along the north coast of Harlen Cove. The mouth to Hartlen Cove is situated on a very exposed coastline, and the smaller size noted by WSP (2018) may have been a result of storm damage, from which it has since been recovering.

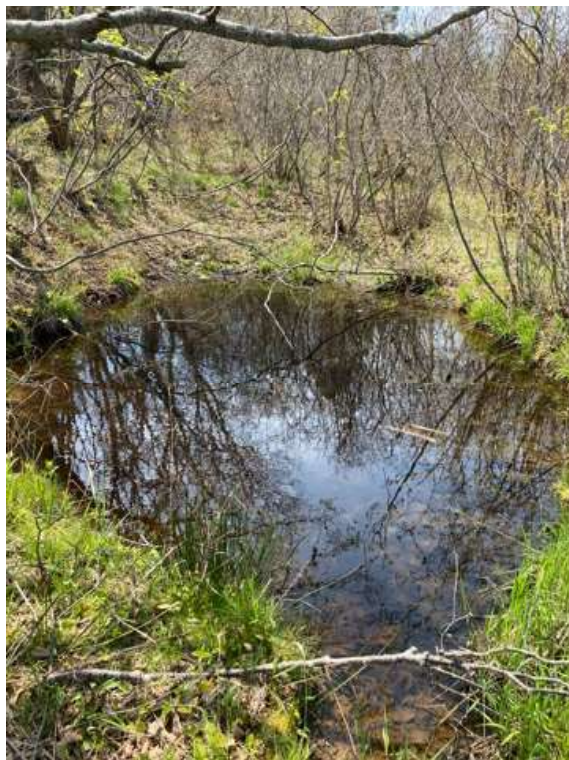
Photo 2: View of standing water (vernal pool) in the non-tidal (tall shrub swamp) portion of HP-2.

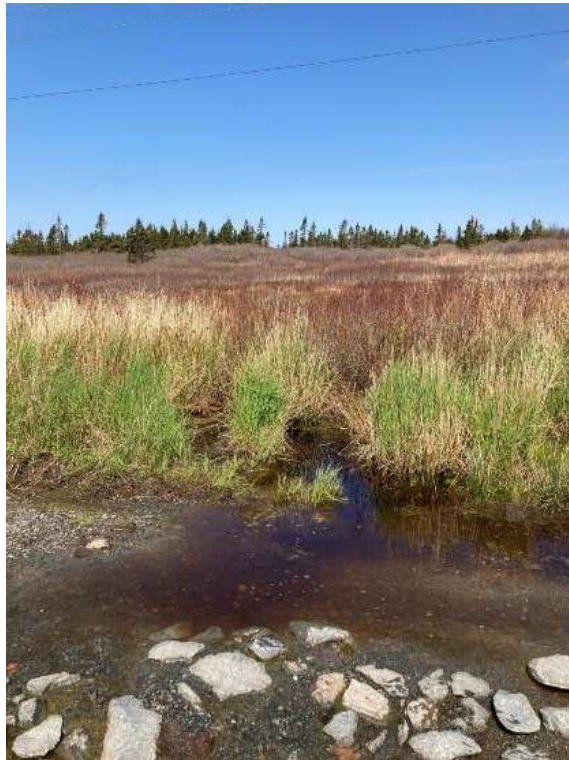
Photo 3: View of HP5 (from access road) and water draining across the access road from HP-5 to HP-6.

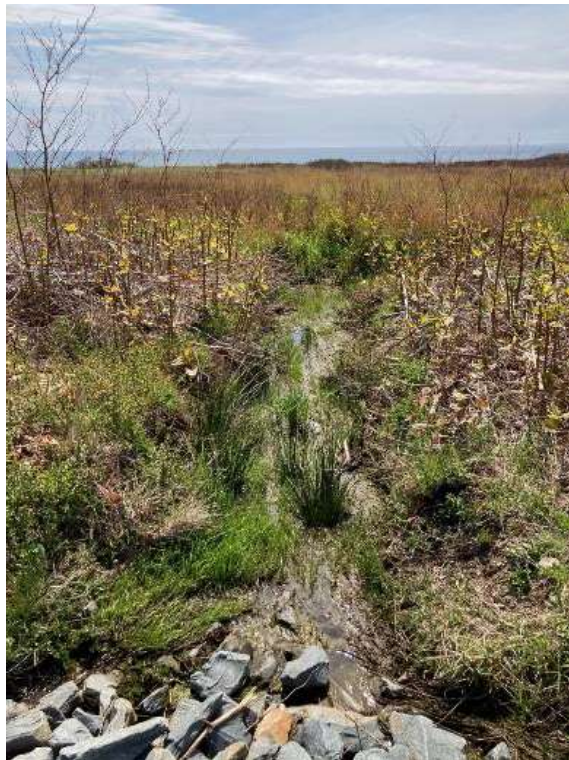
Photo 4: View of HP-6 (from access road) and inflow of drainage from HP-5. Also visible is gravel infill from access road and stalks of Japanese knotweed from last season.

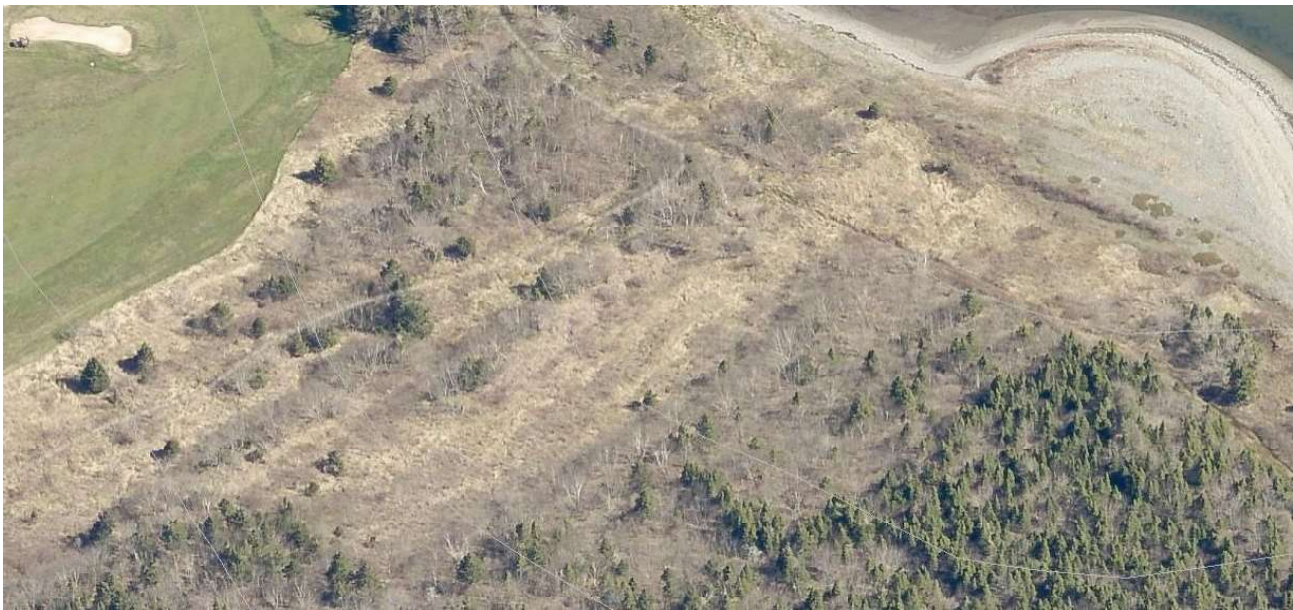
Photo 6: Disturbed area with borderline wetland conditions north of Project footprint.

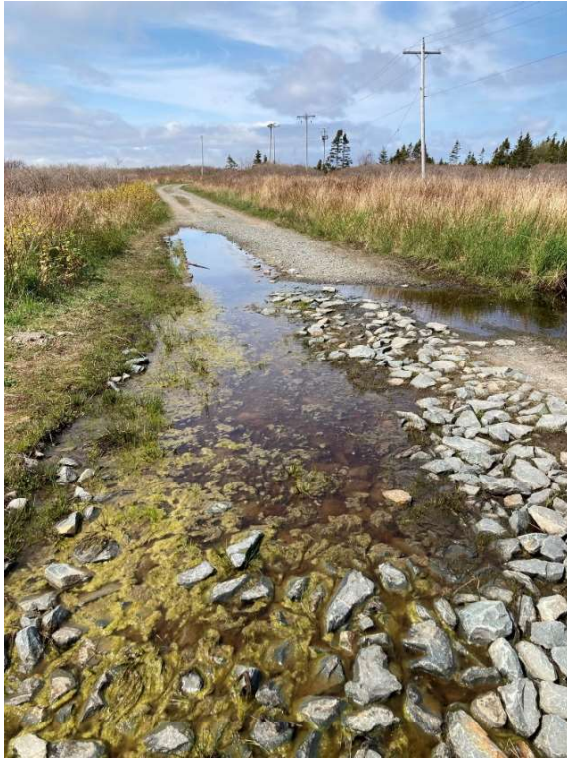
Photo 7: Overflow of water onto gravel road that bisects HP-5 and HP-6.
